Manhole Inspection Summary

Manhole # S35W__026MH

Insp Date: **2/11/08 4:05 PM**

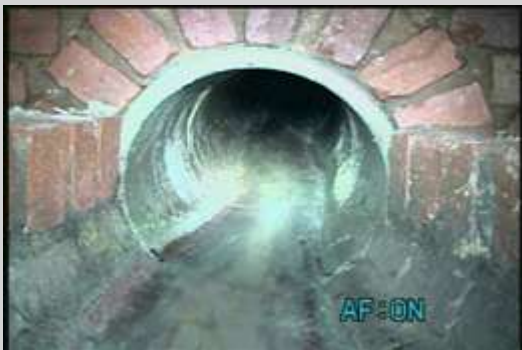
12 O'Clock Outflow

12 in. Circular Gravity Sewer
Pipe Out @ 12 O'Clock

Invert Depth: 11.00 (ft.) Flow Characteristics: Fast

Infiltration: None Pipe Seal Cond: Unknown

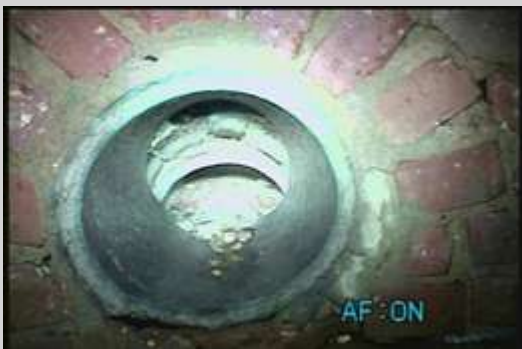
4 O'Clock Inflow

8 in. Circular Gravity Sewer
Pipe In @ 4 O'Clock

Drop In @ 4 O'Clock

Drop: Inside Direct
Angled: Reading: 0.00 (ft.)
Inv Depth: 10.30 (ft.)

Drop Condition: Partly Clogged

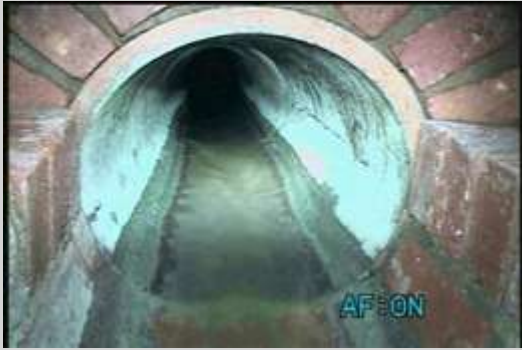
6 O'Clock Inflow

12 in. Circular Gravity Sewer

Pipe In @ 6 O'Clock

Invert Depth: **10.20** (ft.) Flow Characteristics: **Fast**

Infiltration: **None** Pipe Seal Cond: **Unknown**

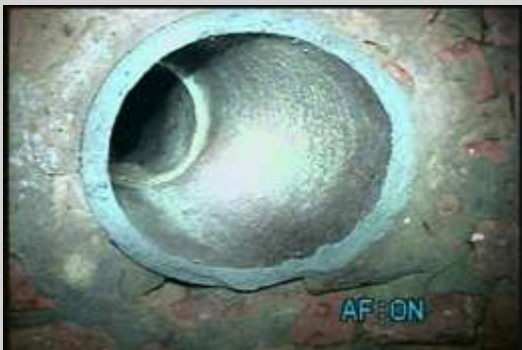
8 O'Clock Inflow

12 in. Circular Gravity Sewer

Pipe In @ 8 O'Clock

Invert Depth: **7.50** (ft.) Flow Characteristics: **Slow**

Infiltration: **None**

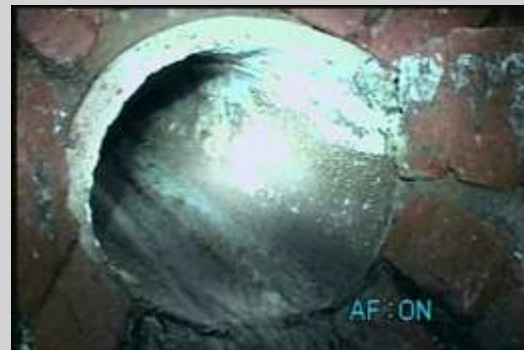
Drop In @ 8 O'Clock

Drop: **Inside** **Direct**

Drop Condition: **Open**
